Ruby Bridges Elementary School

Alameda USD Facilities Assessment

Ruby Bridges Elementary School
Facility Assessment Spreadsheet

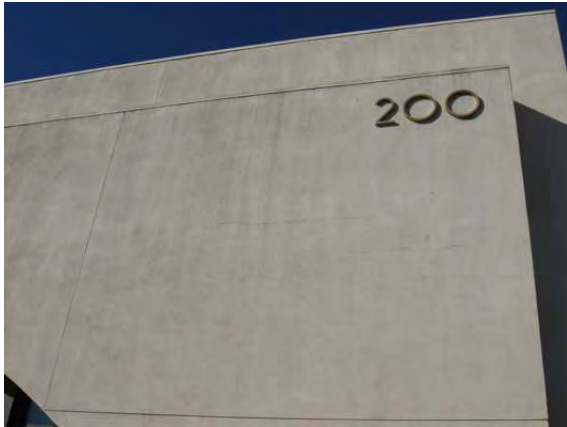
11

CATEGORY		DESCRIPTION	PHOTO & SITE PLAN	ESTIMATED TAKE OFF		COST / UNIT	TOTAL COST
				Quantity	Unit		
5	Existing Deficiency	Day-Care Portable: roof downspout land at wood foundation, with no site drainage & eventual dry rot.	#17, #18, #19				
	Recommended Remedy	Add site drainage inlets direct to downspouts		4	EA	\$1,500	\$6,000
6	Existing Deficiency	Multi-Use Bldg: stucco cracks on larger panels	#11				
	Recommended Remedy	apply zypex filler/sealer and repaint	Allow	8,800	SF	\$4.25	\$37,400

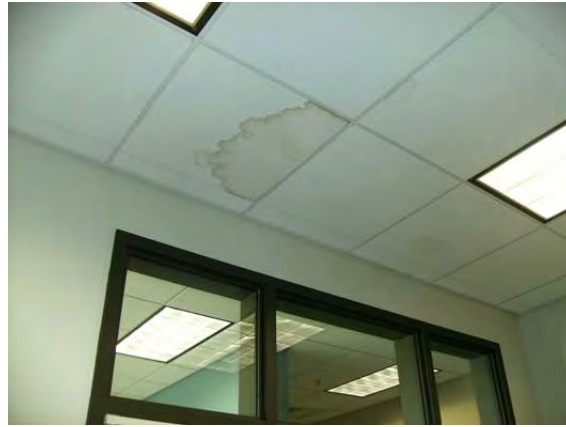
12

B) INTERIOR							
i) GENERAL & MAINTENANCE							
1	Existing Deficiency	SEE ITEM ii) 1 ABOVE	#12				
	Recommended Remedy	Replace damaged ceiling tiles		14	EA	\$5	\$70
2	Existing Deficiency	Classroom C-6: roof leak with stained ceiling tiles	#13, #14, #15				
	Recommended Remedy	If no further leaks, replace stained tiles	Allow	1,100	SF	\$3	\$3,300
