Amelia Earhart Elementary School

SUMMARY OF SCHOOL CAMPUS

Earhart Elementary School
Facility Assessment Spreadsheet

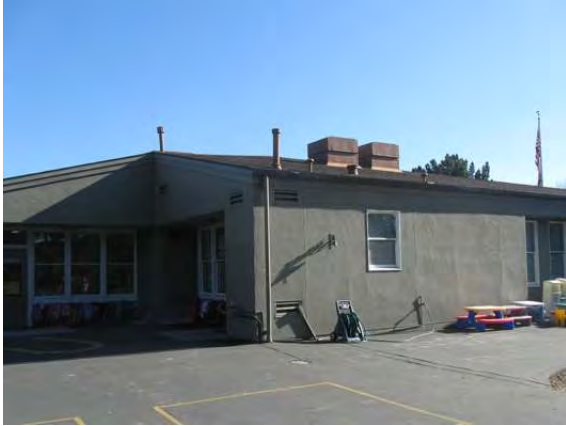
| CATEGORY | | DESCRIPTION | PHOTO & SITE PLAN | ESTIMATED TAKE OFF | | COST / UNIT | TOTAL COST |
|---|---|---|---|---|---|---|---|
| 3 | Existing Deficiency | Classroom Pod A: Drinking Fountain on north side of classroom 3 is non-accessible | #1 | | | | |

| CATEGORY | | DESCRIPTION | PHOTO & SITE PLAN | ESTIMATED TAKE OFF | | COST / UNIT | TOTAL COST |
|---|---|---|---|---|---|---|---|
| | Recommended Remedy | Replace w/ single Accessible D.F. | | 1 | EA | \$3,000 | \$3,000 |

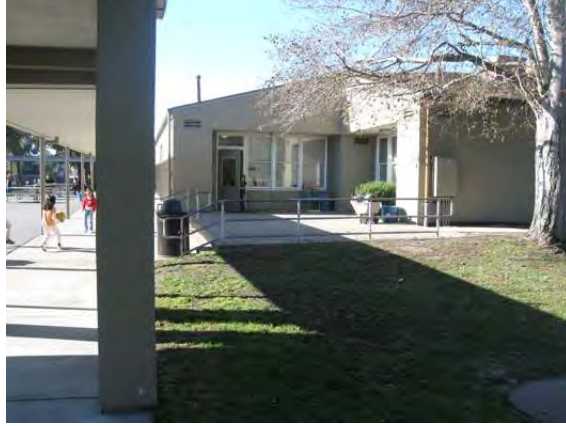
2

| CATEGORY | | DESCRIPTION | PHOTO & SITE PLAN | ESTIMATED TAKE OFF | | COST / UNIT | TOTAL COST |
|---|---|---|---|---|---|---|---|
| 4 | Existing Deficiency | Classroom Pod C: Playground is not accessible from plaza at Room 16 | #2 | | | | |

| CATEGORY | | DESCRIPTION | PHOTO & SITE PLAN | ESTIMATED TAKE OFF | | COST / UNIT | TOTAL COST |
|---|---|---|---|---|---|---|---|
| | Recommended Remedy | Add accessible ramp for direct access | | 120 | SF | \$30.00 | \$3,600 |

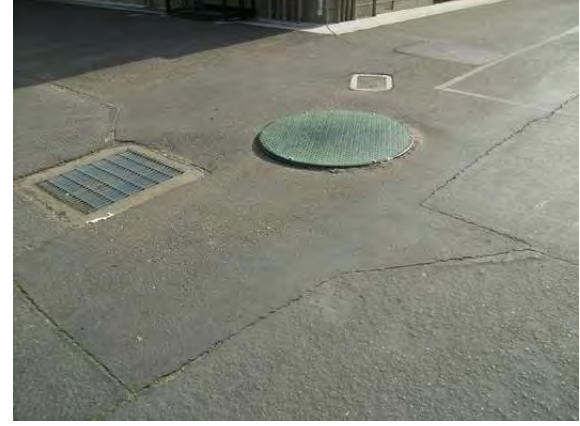
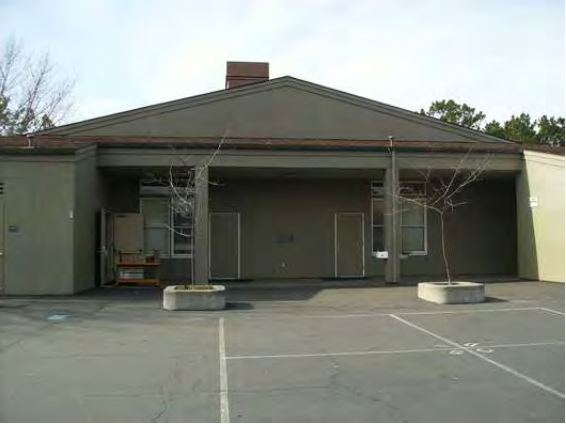
| CATEGORY | | DESCRIPTION | PHOTO & SITE PLAN | ESTIMATED TAKE OFF | | COST / UNIT | TOTAL COST |
|---|---|---|---|---|---|---|---|
| 5 | Existing Deficiency | Playground Surface: asphalt is cracking with many trip hazards. Also see Civil item #8 | #3, #4 | | | | |

| CATEGORY | | DESCRIPTION | PHOTO & SITE PLAN | ESTIMATED TAKE OFF | | COST / UNIT | TOTAL COST |
|---|---|---|---|---|---|---|---|
| | Recommended Remedy | Grind (E) asphalt, regrade, and repave entire play yard | | 10,200 | SF | \$6.00 | \$61,200 |

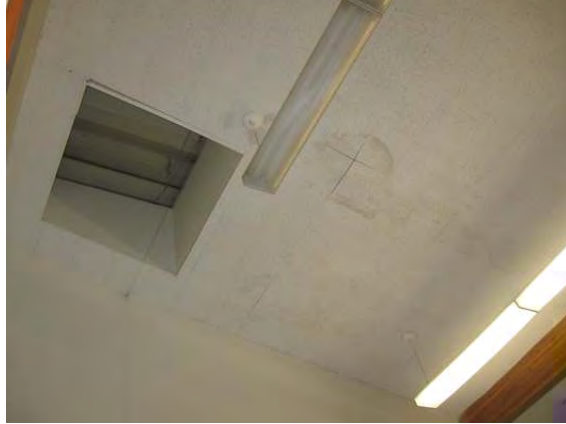
5

| CATEGORY | | DESCRIPTION | PHOTO & SITE PLAN | ESTIMATED TAKE OFF | | COST / UNIT | TOTAL COST |
|---|---|--|---|---|---|---|---|
| 1 | Existing Deficiency | Shuttered skylights: Classroom & Multi-Use shutters not used, due to problematic cable operator | #5, #24 | | | | |
| 6 | Existing Deficiency | Classroom pods: Staff toilets require sanitary cove base per Health Code | #5 | | | | |
| 7 | Existing Deficiency | Admin. & Pod Bldgs: precipitation collects at high point of ceiling | #5, #20, #27 | | | | |

| CATEGORY | | DESCRIPTION | PHOTO & SITE PLAN | ESTIMATED TAKE OFF | | COST / UNIT | TOTAL COST |
|---|---|--|---|---|---|---|---|
| | Recommended Remedy | Install "solatube" daylighting, and convert (E) skylights to 'passive' ventilators | | 20 | EA | \$3,200.00 | \$64,000 |
| | Recommended Remedy | Remove probable VAT flooring at toilets and Commons space. Replace with ceramic tile at toilets, and resilient or carpet elsewhere. | | 6,500 | SF | \$5.00 | \$32,500 |
| | Recommended Remedy | * Investigate insulation of joist space. If unvented, dew point may occur in winter, resulting in condensation and probable framing dry rot. | Allowance for venting & 20% dry rot | 34,900 | SF | \$5.00 | \$174,500 |

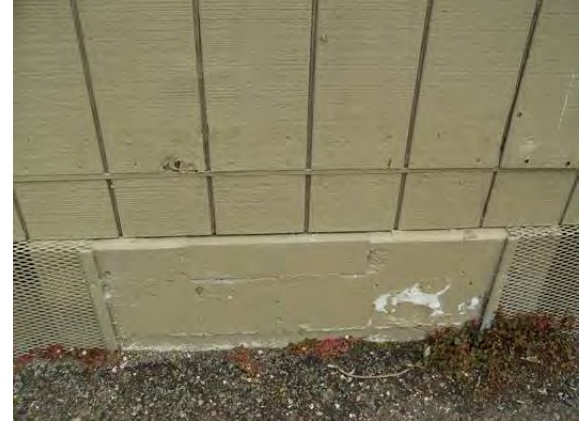
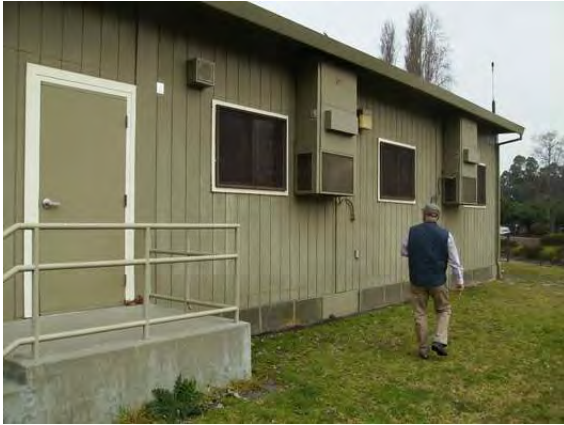
| CATEGORY | DESCRIPTION | PHOTO & SITE PLAN | ESTIMATED TAKE OFF | | COST / UNIT | TOTAL COST |
|---|--|---|---|---|---|---|
| 8 Existing Deficiency | Daycare Modular: wood siding and paint is deteriorated. | #6, #11 | | | | |

| CATEGORY | DESCRIPTION | PHOTO & SITE PLAN | ESTIMATED TAKE OFF | | COST / UNIT | TOTAL COST |
|---|--|---|---|---|---|---|
| Recommended Remedy | Replace wood siding with cement board paneling/ trim and repaint | | 2,688 | SF | \$6.00 | \$16,128 |

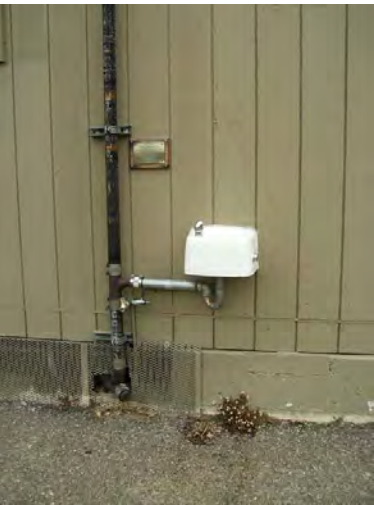
7

| CATEGORY | | DESCRIPTION | PHOTO & SITE PLAN | ESTIMATED TAKE OFF | | COST / UNIT | TOTAL COST |
|---|---|---|---|---|---|---|---|
| 6 | Existing Deficiency | Daycare Modular: Drink fountain is non-compliant | #7 | | | | |

| CATEGORY | | DESCRIPTION | PHOTO & SITE PLAN | ESTIMATED TAKE OFF | | COST / UNIT | TOTAL COST |
|---|---|---|---|---|---|---|---|
| | Recommended Remedy | Replace with compliant model | | 1 | Pair | \$5,000.00 | \$5,000 |

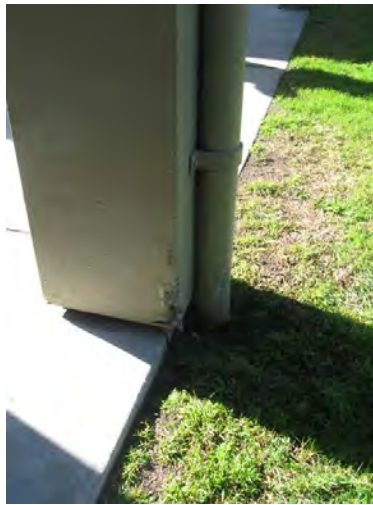
9

| CATEGORY | DESCRIPTION | PHOTO & SITE PLAN | ESTIMATED TAKE OFF | | COST / UNIT | TOTAL COST |
|---|--|---|---|---|---|---|
| 7 Existing Deficiency | Corridor Columns: Damaged cement plaster corners | #9 | | | | |

| CATEGORY | DESCRIPTION | PHOTO & SITE PLAN | ESTIMATED TAKE OFF | | COST / UNIT | TOTAL COST |
|---|--|---|---|---|---|---|
| Recommended Remedy | Repair stucco where damage not likely to occur again; otherwise, add corner guards. | Allow | 1,152 | SF | \$14.00 | \$16,128 |

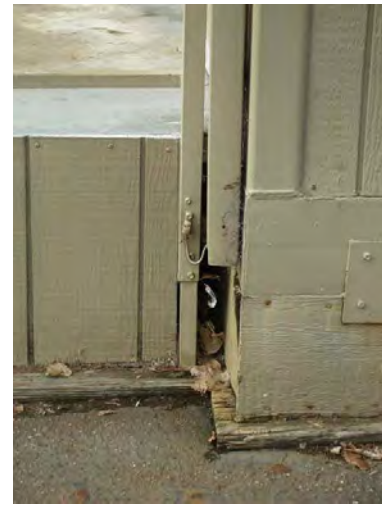
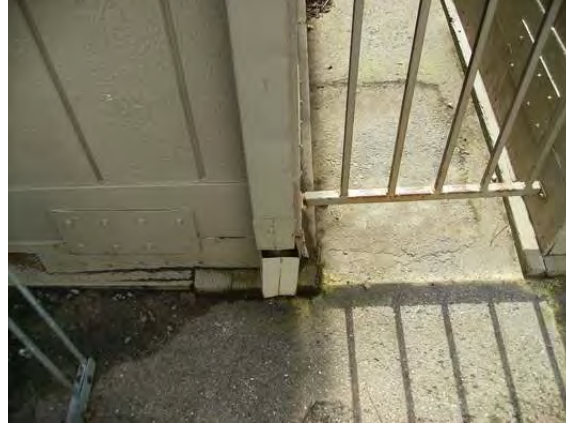
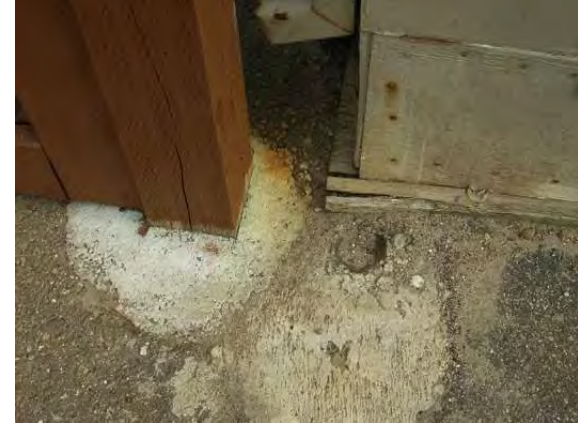
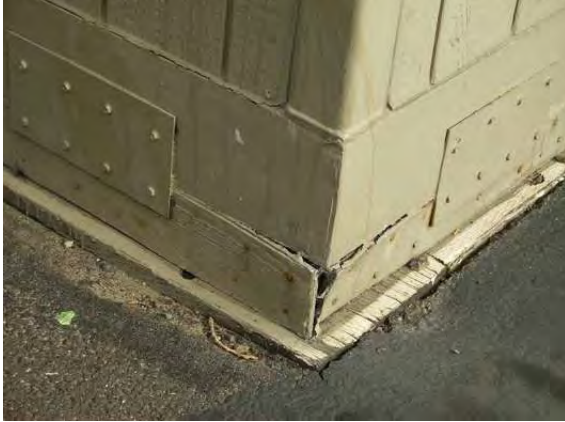
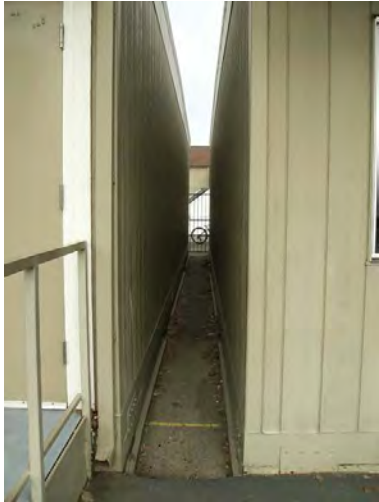
| CATEGORY | DESCRIPTION | PHOTO & SITE PLAN | ESTIMATED TAKE OFF | | COST / UNIT | TOTAL COST |
|---|--|---|---|---|---|---|
| 6 Existing Deficiency | Music Room Portables: Roof downspouts discharge on wood foundation, cause dry rot. | #10, #12, #13, #14, #17 | | | | |

| CATEGORY | DESCRIPTION | PHOTO & SITE PLAN | ESTIMATED TAKE OFF | | COST / UNIT | TOTAL COST |
|---|--|---|---|---|---|---|
| Recommended Remedy | Add site drainage inlets for direct discharge, and replace with concrete foundation/ramps | | 45 | CY | \$850.00 | \$38,250 |

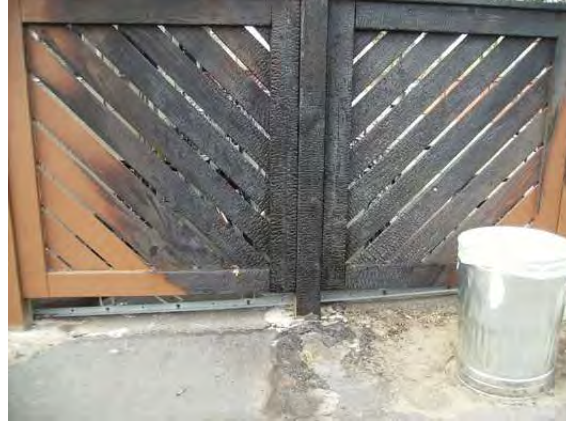
15

| CATEGORY | DESCRIPTION | PHOTO & SITE PLAN | ESTIMATED TAKE OFF | | COST / UNIT | TOTAL COST |
|---|--|---|---|---|---|---|
| 7 Existing Deficiency | Bike Yard Fence: wood fence burned by vandals | #15 | | | | |

| CATEGORY | DESCRIPTION | PHOTO & SITE PLAN | ESTIMATED TAKE OFF | | COST / UNIT | TOTAL COST |
|---|--|---|---|---|---|---|
| Recommended Remedy | Remove burned fence and replace with new chainlink bike cage | | 160 | LF | \$60.00 | \$9,600 |

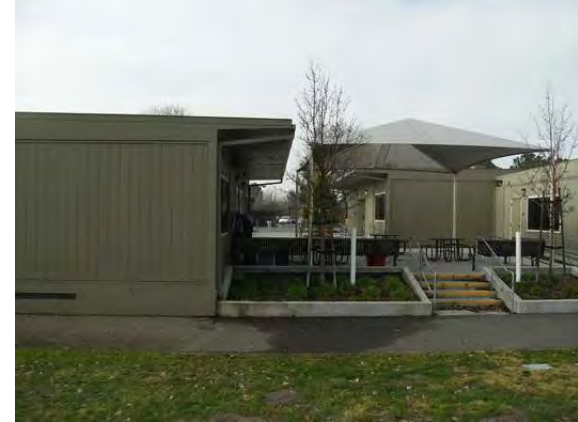
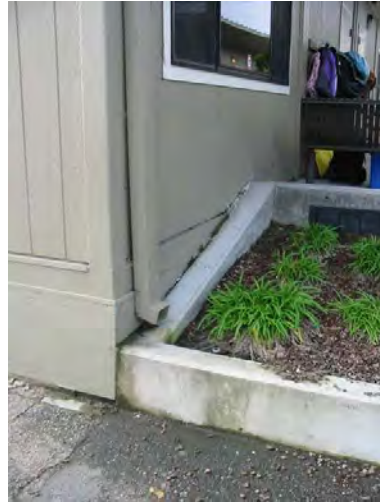
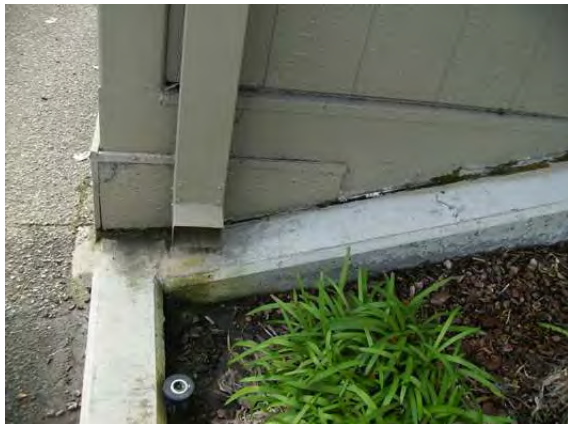
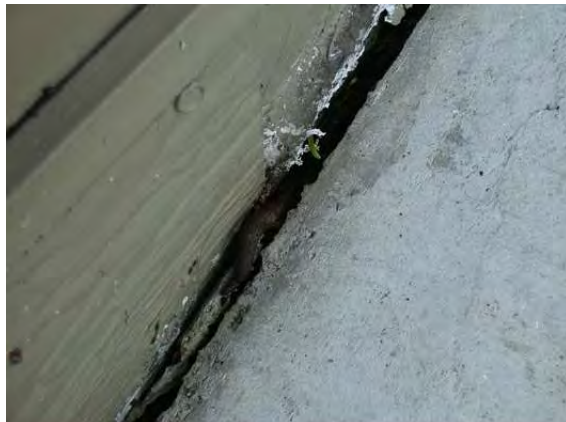
| CATEGORY | DESCRIPTION | PHOTO & SITE PLAN | ESTIMATED TAKE OFF | | COST / UNIT | TOTAL COST |
|---|--|---|---|---|---|---|
| 8 Existing Deficiency | 6 Room Portable Pod: roof downspouts saturate wood foundation, causing dry rot | #16, #18, #21, #22 | | | | |

| CATEGORY | DESCRIPTION | PHOTO & SITE PLAN | ESTIMATED TAKE OFF | | COST / UNIT | TOTAL COST |
|---|--|---|---|---|---|---|
| Recommended Remedy | Add site drainage inlet for downspouts; design a metal flashing detail for concrete to wood connection | Allow | 1 | LS | \$8,000.00 | \$8,000 |

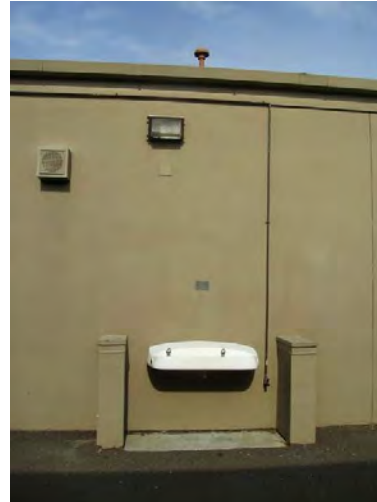
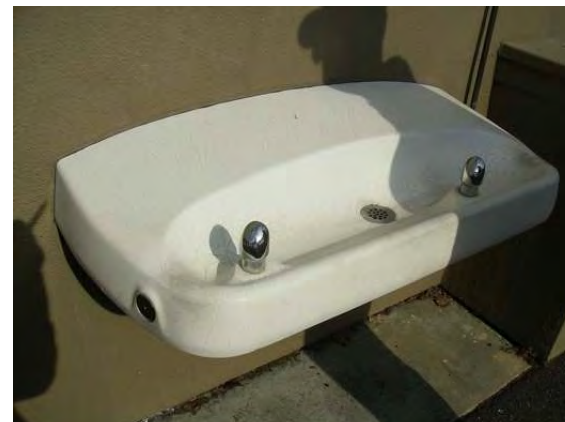
| CATEGORY | DESCRIPTION | PHOTO & SITE PLAN | ESTIMATED TAKE OFF | | COST / UNIT | TOTAL COST |
|---|--|---|---|---|---|---|
| 9 Existing Deficiency | Multi-Use Bldg: exterior drink fountain is non accessible compliant | #19, #23 | | | | |

| CATEGORY | DESCRIPTION | PHOTO & SITE PLAN | ESTIMATED TAKE OFF | | COST / UNIT | TOTAL COST |
|---|--|---|---|---|---|---|
| Recommended Remedy | Reset at correct height and place padded boot on drain line, or replace | | 1 | EA | \$5,000.00 | \$5,000 |

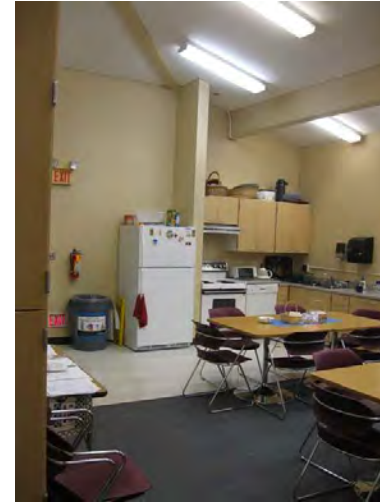
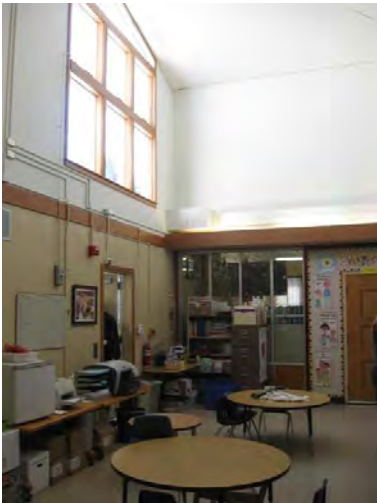
Further investigation of the roof framing system should be performed to determine if the sloped roof insulation is properly vented, to prevent condensation forming at the dew point of the composite assembly during the winter heating cycle. If not vented, the condensation build up over time may have caused dry rot infestation in the structural framing members.

| CATEGORY | | DESCRIPTION | PHOTO & SITE PLAN | ESTIMATED TAKE OFF | | COST / UNIT | TOTAL COST |
|---|---|---|---|---|---|---|---|
| | Recommended Remedy | Repair/ reframe Dry Rot roof or wall framing | ALLOW | 1 | LS | \$30,000.00 | \$30,000 |

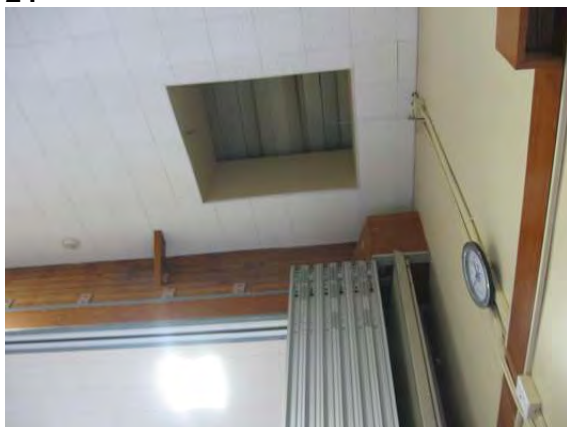
24

| CATEGORY | | DESCRIPTION | PHOTO & SITE PLAN | ESTIMATED TAKE OFF | | COST / UNIT | TOTAL COST |
|---|---|--|---|---|---|---|---|
| 2 | Existing Deficiency | Multi-Use Bldg: moveable panels at ridge beam, bind when moved. | #24 | | | | |

| CATEGORY | | DESCRIPTION | PHOTO & SITE PLAN | ESTIMATED TAKE OFF | | COST / UNIT | TOTAL COST |
|---|---|--|---|---|---|---|---|
| | Recommended Remedy | Replace heavy panels with manual lightweight panels | | 75 | LF | \$75.00 | \$5,625 |

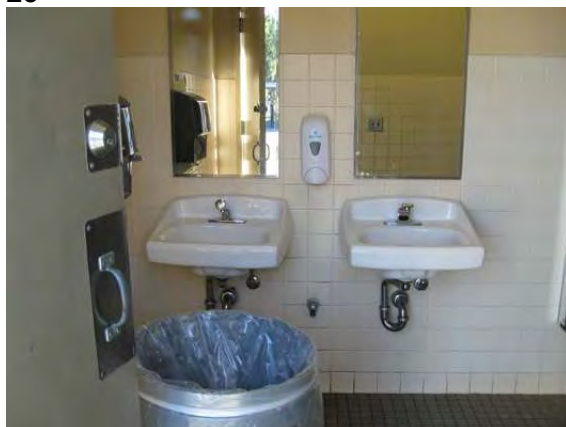
25

| CATEGORY | | DESCRIPTION | PHOTO & SITE PLAN | ESTIMATED TAKE OFF | | COST / UNIT | TOTAL COST |
|---|---|--|---|---|---|---|---|
| 5 | Existing Deficiency | Multi-Use Toilets: sinks are non accessible compliant | #25 | | | | |

| CATEGORY | | DESCRIPTION | PHOTO & SITE PLAN | ESTIMATED TAKE OFF | | COST / UNIT | TOTAL COST |
|---|---|--|---|---|---|---|---|
| | Recommended Remedy | Add padded drain line cover | | 6 | EA | \$1,000.00 | \$6,000 |

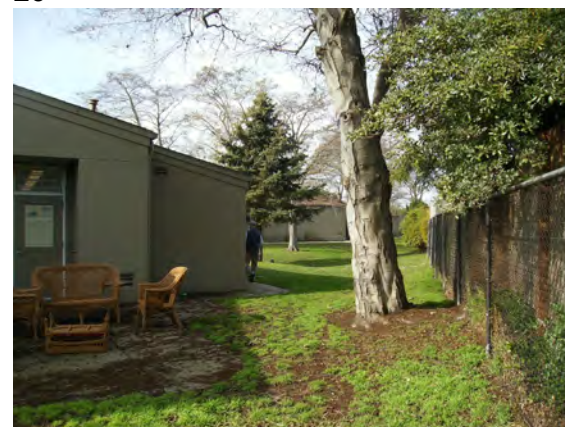
26

| CATEGORY | | DESCRIPTION | PHOTO & SITE PLAN | ESTIMATED TAKE OFF | | COST / UNIT | TOTAL COST |
|---|---|---|---|---|---|---|---|
| 2 | Existing Deficiency | Students walk in grassy area north of Pods A, B & F. | #26 | | | | |

| CATEGORY | | DESCRIPTION | PHOTO & SITE PLAN | ESTIMATED TAKE OFF | | COST / UNIT | TOTAL COST |
|---|---|---|---|---|---|---|---|
| | Recommended Remedy | Add concrete walkway in grass area, connecting plazas on north side of Pods. | | 400 | SF | \$17.00 | \$6,800 |

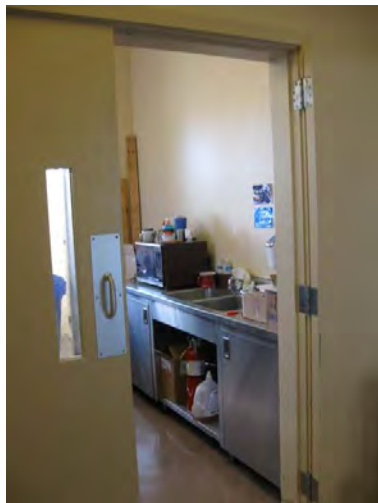
28

| CATEGORY | | DESCRIPTION | PHOTO & SITE PLAN | ESTIMATED TAKE OFF | | COST / UNIT | TOTAL COST |
|---|---|--|---|---|---|---|---|
| 8 | Existing Deficiency | Cafeteria Kitchen: service sink is non accessible and wall/floor finish is not Health Code compliant | #28 | | | | |

| CATEGORY | | DESCRIPTION | PHOTO & SITE PLAN | ESTIMATED TAKE OFF | | COST / UNIT | TOTAL COST |
|---|---|--|---|---|---|---|---|
| | Recommended Remedy | Refinish wall w/ FRP and floor/cove with applied Epoxy. Replace sink | | 1 | LS | \$18,000.00 | \$18,000 |
