Longfellow/ Woodstock Child Development Center

LONGFELLOW/WCDC & NEA
4/30/2012

Alameda USD Facilities Assessment

Facility Assessment Spreadsheet

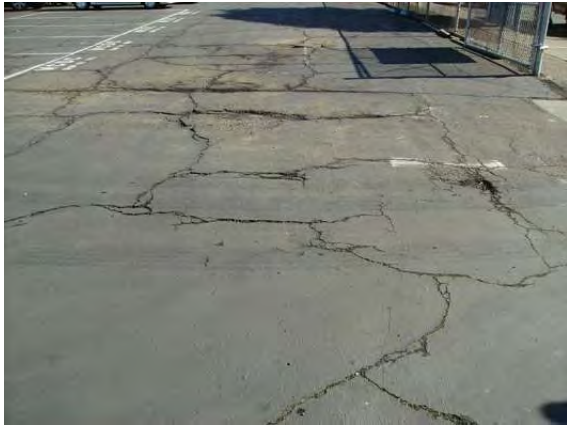
2) Architectural							\$1,093,278
A) EXTERIOR							
i) ACCESS							
1	Existing Deficiency	Parking & Playground: asphalt cracking and damage w/ trip hazards	#1, #2, #3				
	Recommended Remedy	Grind existing, regrade and repave. Parking lot = 24,000 sf; Playground = 30,000 sf		See Civil Item #11			Included above
ii) DEFERRED MAINTENANCE							
1	Existing Deficiency	Admin/MP Bldg: stucco cracking; moisture penetration; assume extensive framing dry rot	#5, #6				
	Recommended Remedy	Replace wall/ plate framing (assume 20%); redesign exterior and apply metal cladding and new stucco		1,600	SF	\$20.00	\$32,000
2	Existing Deficiency	Chainlink Fence: east (18-ft) and south (6-ft) property line fencing is very rusted and unsafe	#28				
	Recommended Remedy	Replace chainlink fencing to match existing heights		2,600	SF	\$7.00	\$18,200
3	Existing Deficiency	CDC & NEA Admin. Bldgs: BUR roof at end of service life

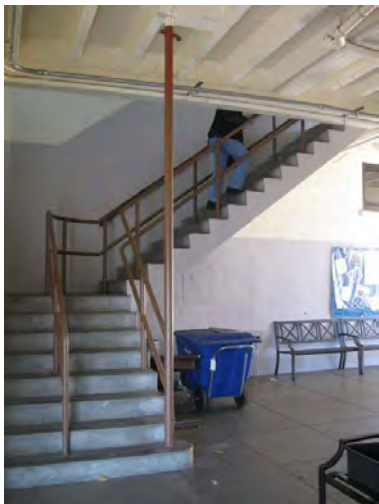
CATEGORY	DESCRIPTION	PHOTO & SITE PLAN	ESTIMATED TAKE OFF		COST / UNIT	TOTAL COST
			Quantity	Unit		
4 Existing Deficiency	NEA 2-Story Wing: handrails at stairs are non-compliant	#7				
Recommended Remedy	Extend steel pipe handrail		1	LS	\$6,000	\$6,000
5 Existing Deficiency	NEA Bldg: plywood clad 1-story wood frame addition is deteriorated	#8, #9				
Recommended Remedy	Reclad in cement board/trim		1,600	SF	\$12.00	\$19,200
6 Existing Deficiency	Exterior doors: doors have deteriorated, end of service life.	#10, #11				
Recommended Remedy	Replace all exterior doors with metal jamb and FRP doors with new hardware & high security keying		28	EA	\$4,400	\$123,200
7 Existing Deficiency	Exterior windows w/ Plexiglas beyond Service life					
Recommended Remedy	Replace all windows with Alum. frame & dual pane glass		2,900	SF	\$44.00	\$127,600
8 Existing Deficiency	No Trash Enclosure at this Site					
Recommended Remedy	Install a 2-Bin Trash Enclosure per Health Dept. standards		1	LS	\$15,000	\$15,000

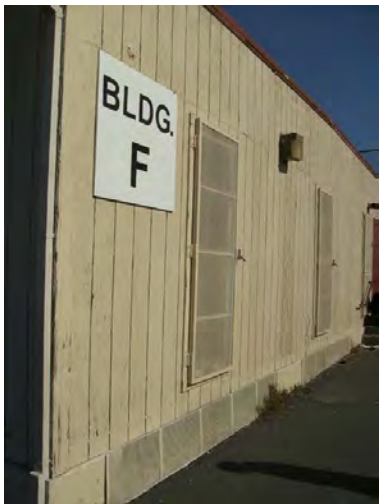
17

9 Existing Deficiency	Exterior painted finish is deteriorated					
Recommended Remedy	Reseal and repaint all exterior walls, trims fascia, etc.		35,182	SF	\$2.00	\$70,364
10 Existing Deficiency	Bldg. F Modular: wood siding/trim is deteriorated; vent screen broken; roofing deteriorated	#17, #18, #19				
Recommended Remedy	Replace wood siding with cement board panel/trim; replace metal roof, vent screens, prep and repaint		1,920	SF	\$15.00	\$28,800
11 Existing Deficiency	CDC Portable: steel framing corrosion; vents missing; ramp handrails missing	#12, #13, #14				
Recommended Remedy	Replace with cement bd. panel/trim, prep metal and repaint; Replace with concrete foundation/ ramp with correct handrails		1,536	SF	\$40.00	\$61,440

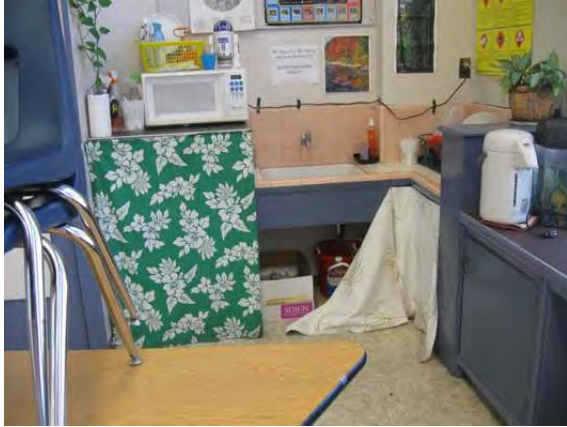
21

7 Existing Deficiency	NEA 2-Story Classrooms: sinks are non-compliant; 2nd Fl. Drink fountain is non-compliant for door clearance	#21, #22				
Recommended Remedy	Replace or remove classroom sinks; relocate D.F.		8	Sinks	\$3,200.00	\$25,600

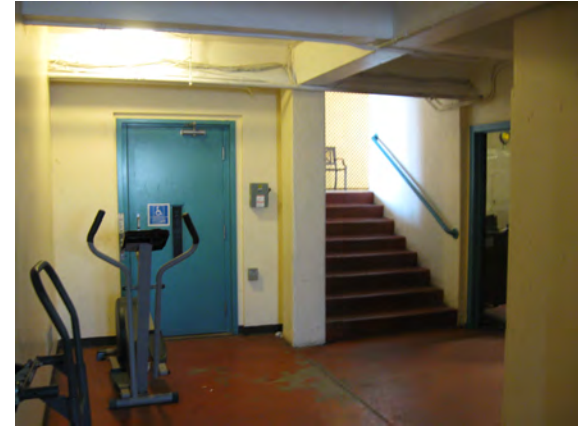
23

CATEGORY	DESCRIPTION	PHOTO & SITE PLAN	ESTIMATED TAKE OFF		COST / UNIT	TOTAL COST
			Quantity	Unit		
3 Existing Deficiency	MU/Admin. Basement Floor/Stairs: (E) paint is worn off and slippery	#23				
Recommended Remedy	Replace painted floor with applied epoxy flooring		4,500	SF	\$12.00	\$54,000
4 Existing Deficiency	Multi-Use Kitchen: non-complaint sink; flooring and cove base; Not large enough for food program	#20, #24				
Recommended Remedy	Repurpose for larger space allocation; replace cabinetry, sink, flooring, and wall covering per Health Code.		1,100	SF	\$125.00	\$137,500
5 Existing Deficiency	NEA Admin Bldg: ceiling water stains ; plaster ceiling removed	#15, #16				
Recommended Remedy	Replace plaster with GWB, and repaint.		600	SF	\$10.00	\$6,000
6 Existing Deficiency	Bldg A CDC Wing: Boys & Girls toilets - lightwell plaster damage; floor deterioration	#25, #26, #27				
Recommended Remedy	Replace skylight unit, repair wall damage, repaint. Replace floor paint with epoxy flooring.		600	SF	\$55.00	\$33,000

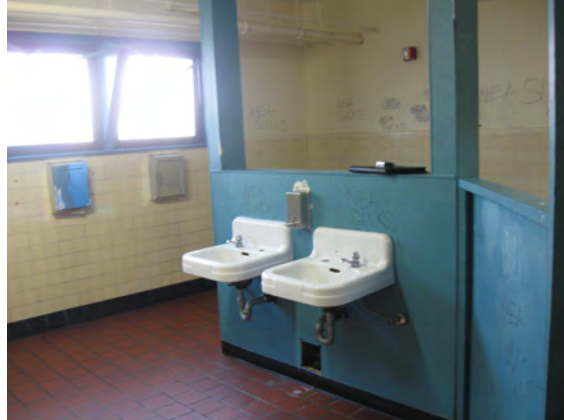
29

CATEGORY		DESCRIPTION	PHOTO & SITE PLAN	ESTIMATED TAKE OFF		COST / UNIT	TOTAL COST
				Quantity	Unit		
B) Interior							
i) EXISTING SYSTEMS							
1	Existing Restrooms-	MU/Admin Bldg: Basement toilets are beyond service life	#29, #30				
	Recommended Remedy	Replace all fixtures; upgrade to epoxy flooring, new tile walls, new partitions, and lights fixtures. Replace all plumbing fixtures, complete, including, urinals (0.125 gpf), water closets (1.28gpf), and lavatories (0,5gpm) to bring into current code compliance and reduce water consumption.		520	SF	\$120.00	\$62,400
2	Existing Systems	Boiler, (Raypack) and related equipment are in fair-good condition, but is inefficient. Piping uninulated and no expansion tank. Systems are combo steam/hot water..					
	Recommended Remedy	District has requested all boilers, pumps, piping and related equipment be replaced with ductless split heat pumps, one system per room.		35,182	SF	\$8.00	\$281,456
