Franklin Elementary School

FRANKLIN ES
4/30/2012

Alameda USD Facilities Assessment

Franklin Elementary School
Facility Assessment Spreadsheet

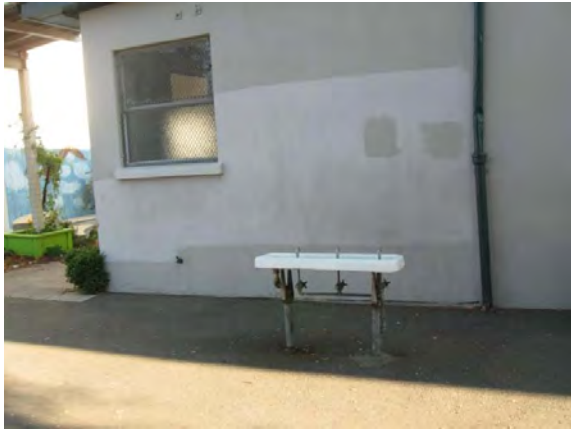
2) Architectural							\$982,705
A) Exterior							
i) ACCESS							
1	Existing Deficiency	Playground: drink fountain is non-accessible	#1				
	Recommended Remedy	Replace with accessible fountain		1	PAIR	\$4,200	\$4,200
ii) DEFERRED MAINTENANCE							
1	Existing Deficiency	Play Yard: Equipment outdated and liability					
	Recommended Remedy	Replace with certified Playground equipment		1	LS	\$35,000	\$35,000
2	Existing Deficiency	2nd Fl. Corridor: chainlink enclosure is rusted and loose					
	Recommended Remedy	Replace chainlink with metal fence tubing enclosure		175	LF	\$45	\$7,875
3	Existing Deficiency	No Trash Enclosure at this Site					
	Recommended Remedy	Install a 2-Bin Trash Enclosure per Health Dept. standards		1	LS	\$15,000	\$15,000
4	Existing Deficiency	Exterior Doors: wood doors degraded at end of service life	#2, #3				
	Recommended Remedy	Replace with galv. steel frames with FRP doors and new hardware		24	EA	\$4,700	\$112,800

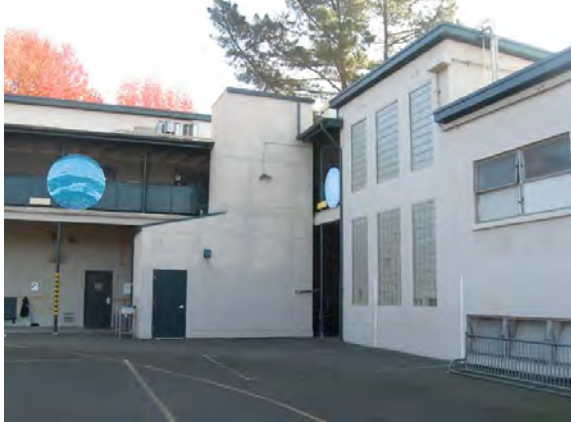
4

5	Existing Deficiency	Wood fascia and trim: paint is chipping/ peeling Stucco: Paint is faded and color mis-match	#5, #6 #4				
	Recommended Remedy	Prep and repaint all wood, and stucco walls	FLOOR AREA	18,150	SF	\$7	\$127,050

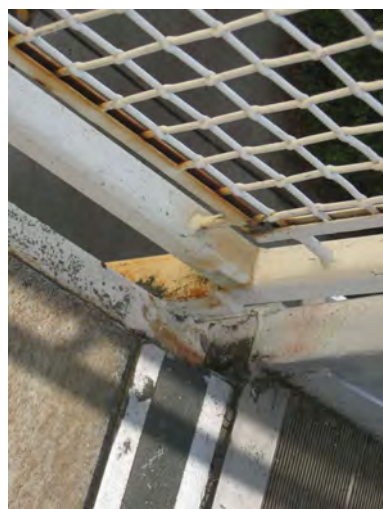
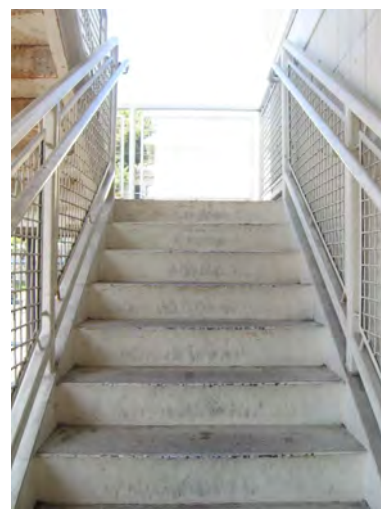
17

Recommended Remedy	Replace south, west and east exterior w/ cement panel/trim and repaint.		12,600	SF	\$12	\$151,200
11	Existing Deficiency	Modular Stairs/Rails: excessive rust; expansion gap at alum ramp to Bldg. exceeds max. for accessibility.	#17, #18				
	Recommended Remedy	prep, treat and repaint all steel; add expansion cover at gap..		2	SETS	\$18,000	\$36,000

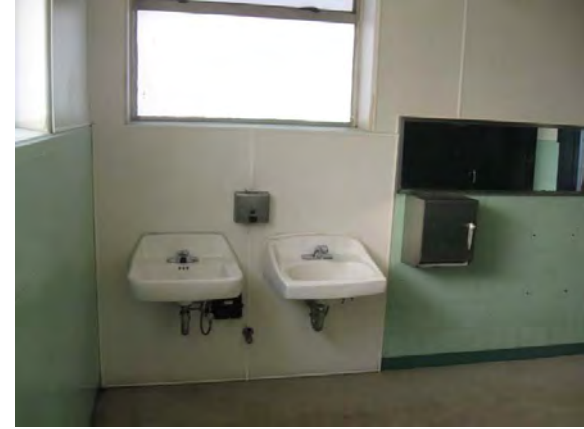
23

i) GENERAL & MAINTENANCE							
1	Existing Deficiency	Classroom/ corridor flooring at end of service life					
	Recommended Remedy	Replace all flooring with resilient flooring, and walk-off Entry carpet mat.		28,000	SF	\$5.00	\$140,000
2	Existing Deficiency	Interior painting wall covering at end of service life					
	Recommended Remedy	Repaint all interiors		28,000	SF	\$2.00	\$56,000
3	Existing Deficiency	Health Office: office student toilet in non-accessible	#20				
	Recommended Remedy	Reconfigure Health office/ toilet		1	LS	\$5,000	\$5,000
4	Existing Deficiency	Restroom Sinks: missing drain boots	#23				
	Recommended Remedy	Add accessible boot covers		8	EA	\$75	\$600
