Wood Middle School - Background Information

Alameda Unified School District Facilities Master Plan

Wood Middle School - Existing Conditions Summary

Wood Middle School - Facilities Needs Spreadsheet

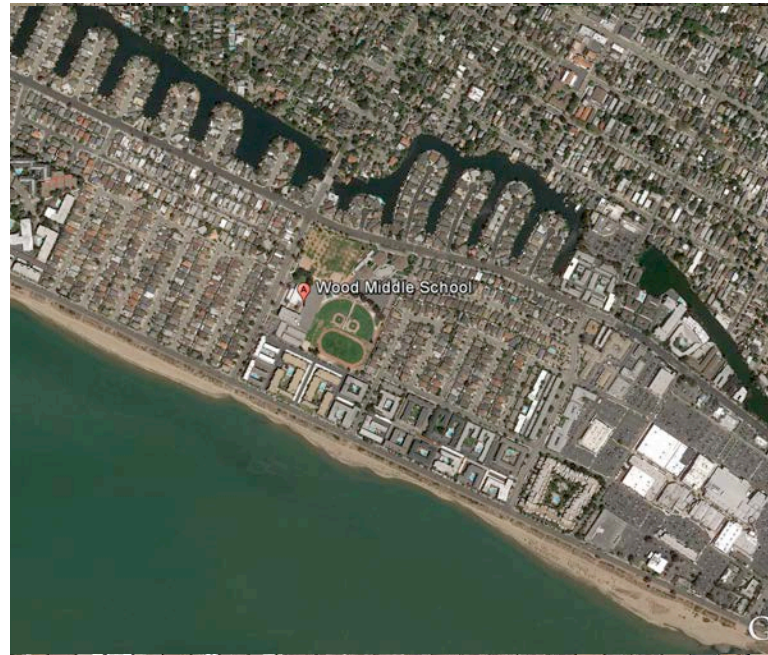
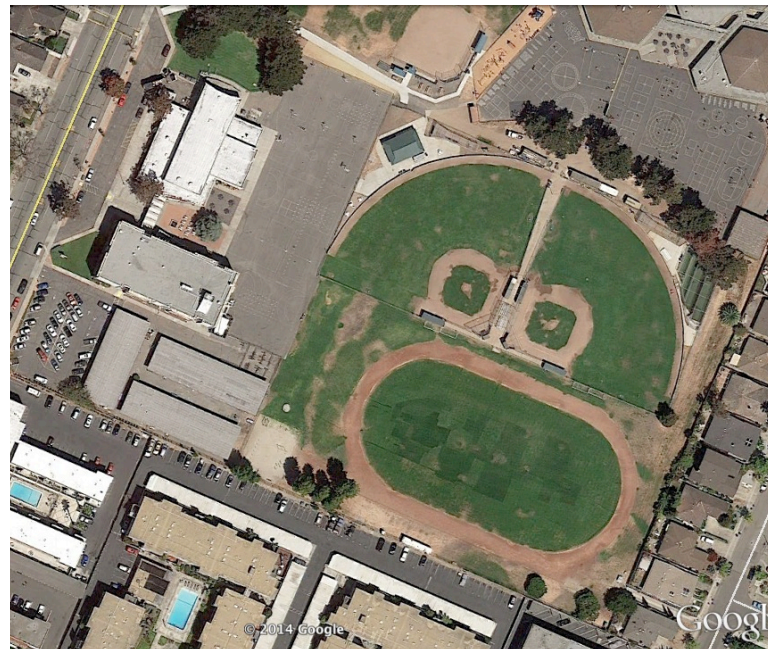
- Modular classroom wings are at the end of their service life.
- Excessive asphalt deterioration
- Corridor lockers are at end of their service life.
- Interior flooring, walls, and ceilings are at end of their service life.
- Gym flooring is deteriorated and delaminating from excessive moisture.
- Telecom, data, speaker, and fire alarm wiring are all exposed in classroom corridors.
- Mechanical and plumbing fixtures are at end of their service life.
- This school does not have an energy-management system.
- Lighting is inefficient and at end of its service life.
- Provide secure perimeter fencing.
