**Alameda Unified School District
Historic Alameda High School
Community Engagement Project
Meeting Number 4**

**Presentation of Costs for
Various Rehabilitation Standards**

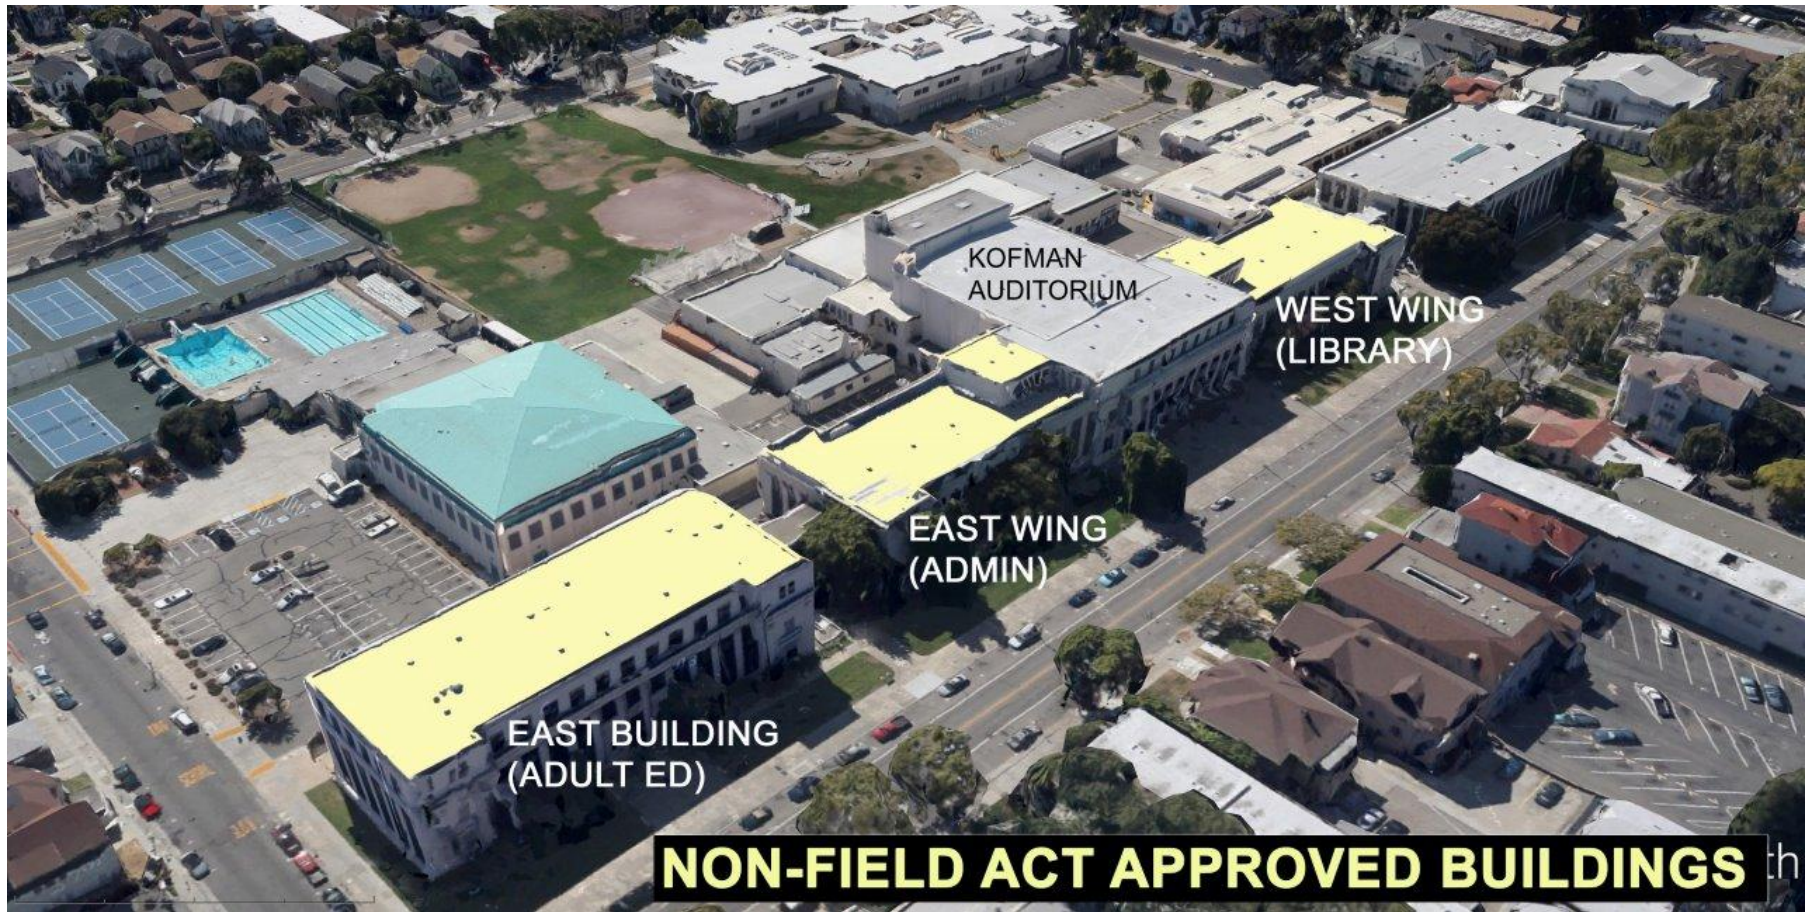
IV: Identification of Affected Buildings

- East Building (Adult Education) – 35,000 sq. ft
- East Wing of Kofman (Administration) – 20,000 sq. ft.
- West Wing of Kofman (Library) – 20,000 sq. ft.
- Kofman Auditorium & West Building are not affected

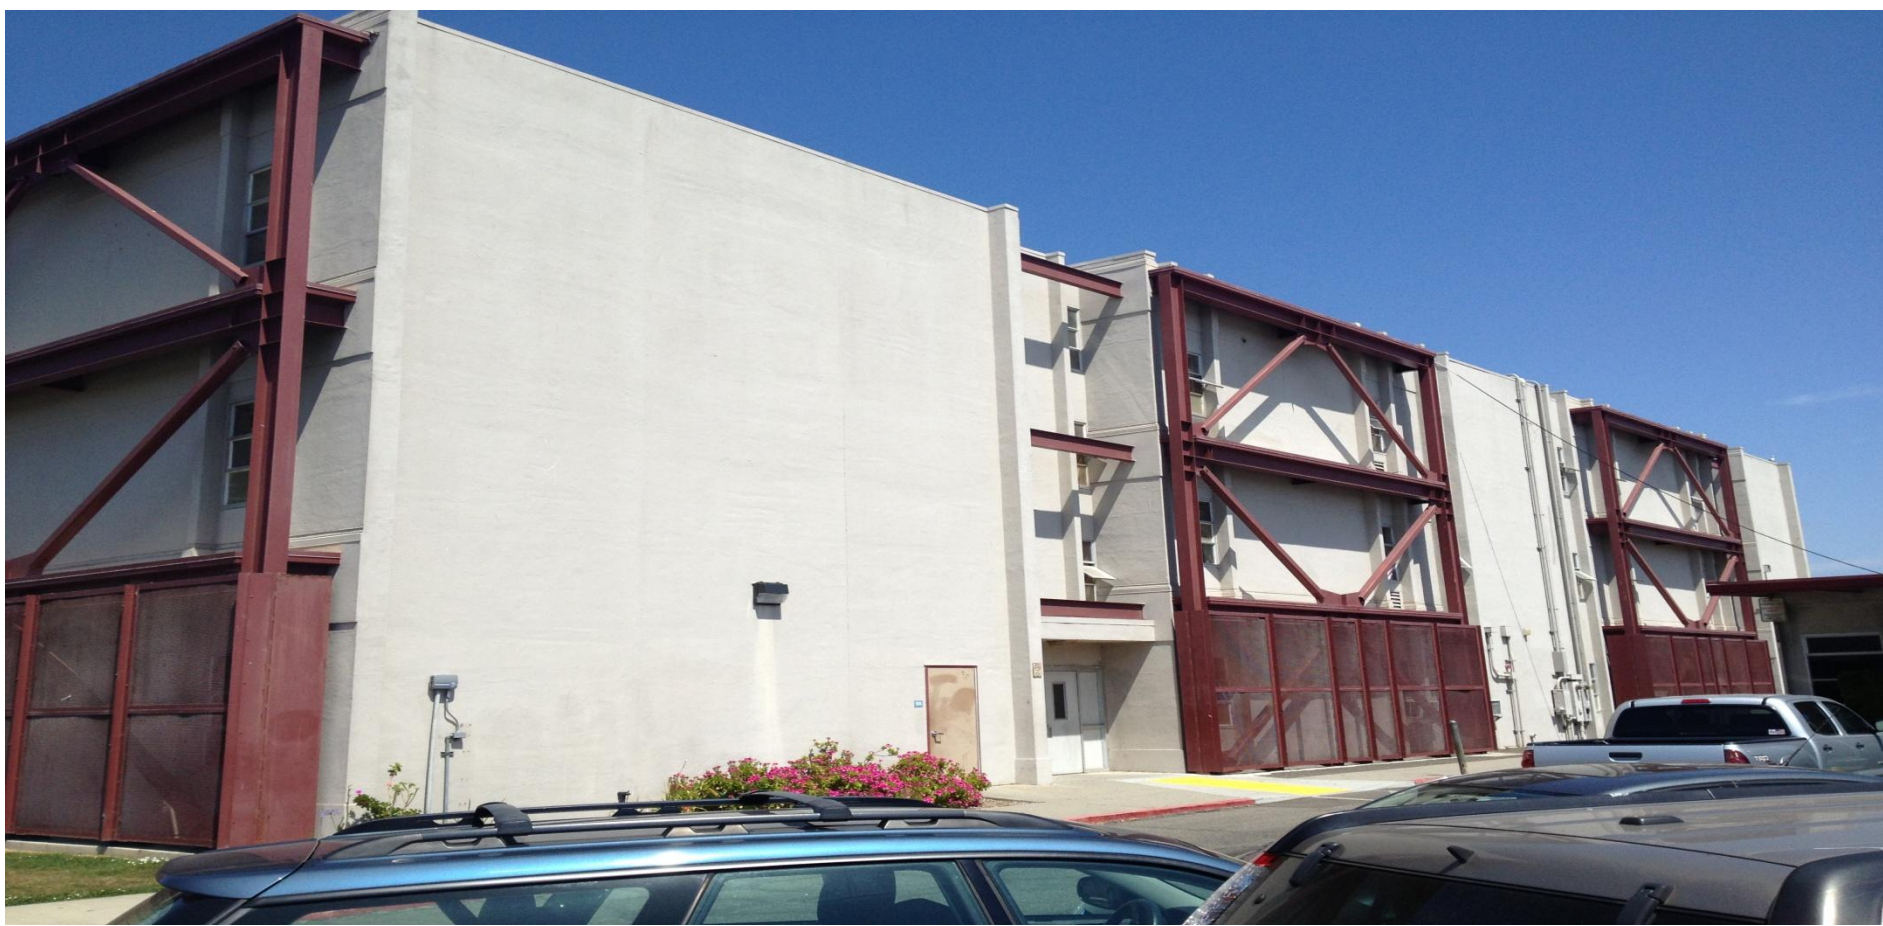
- At the present time, most of the second floor (first floor ceiling) perimeter has been secured to the exterior walls. However, the majority of the third floor and roof sections have not been secured to the exterior walls with one exception. The floor and roof sections that abut the exterior wall parallel to Oak Street have been secured. These areas were not secured as a cost savings measure while the District determined next steps. This is why the containment fence is further away on Central Avenue side of the structures. Consequently, there is currently a possibility that sections of the upper floors and roof could separate from the exterior wall during a major seismic event creating the opportunity for portions of the upper wall to fall outward.
