Longfellow/ Woodstock Child Development Center

LONGFELLOW/WCDC & NEA
4/30/2012

Alameda USD Facilities Assessment

Facility Assessment Spreadsheet

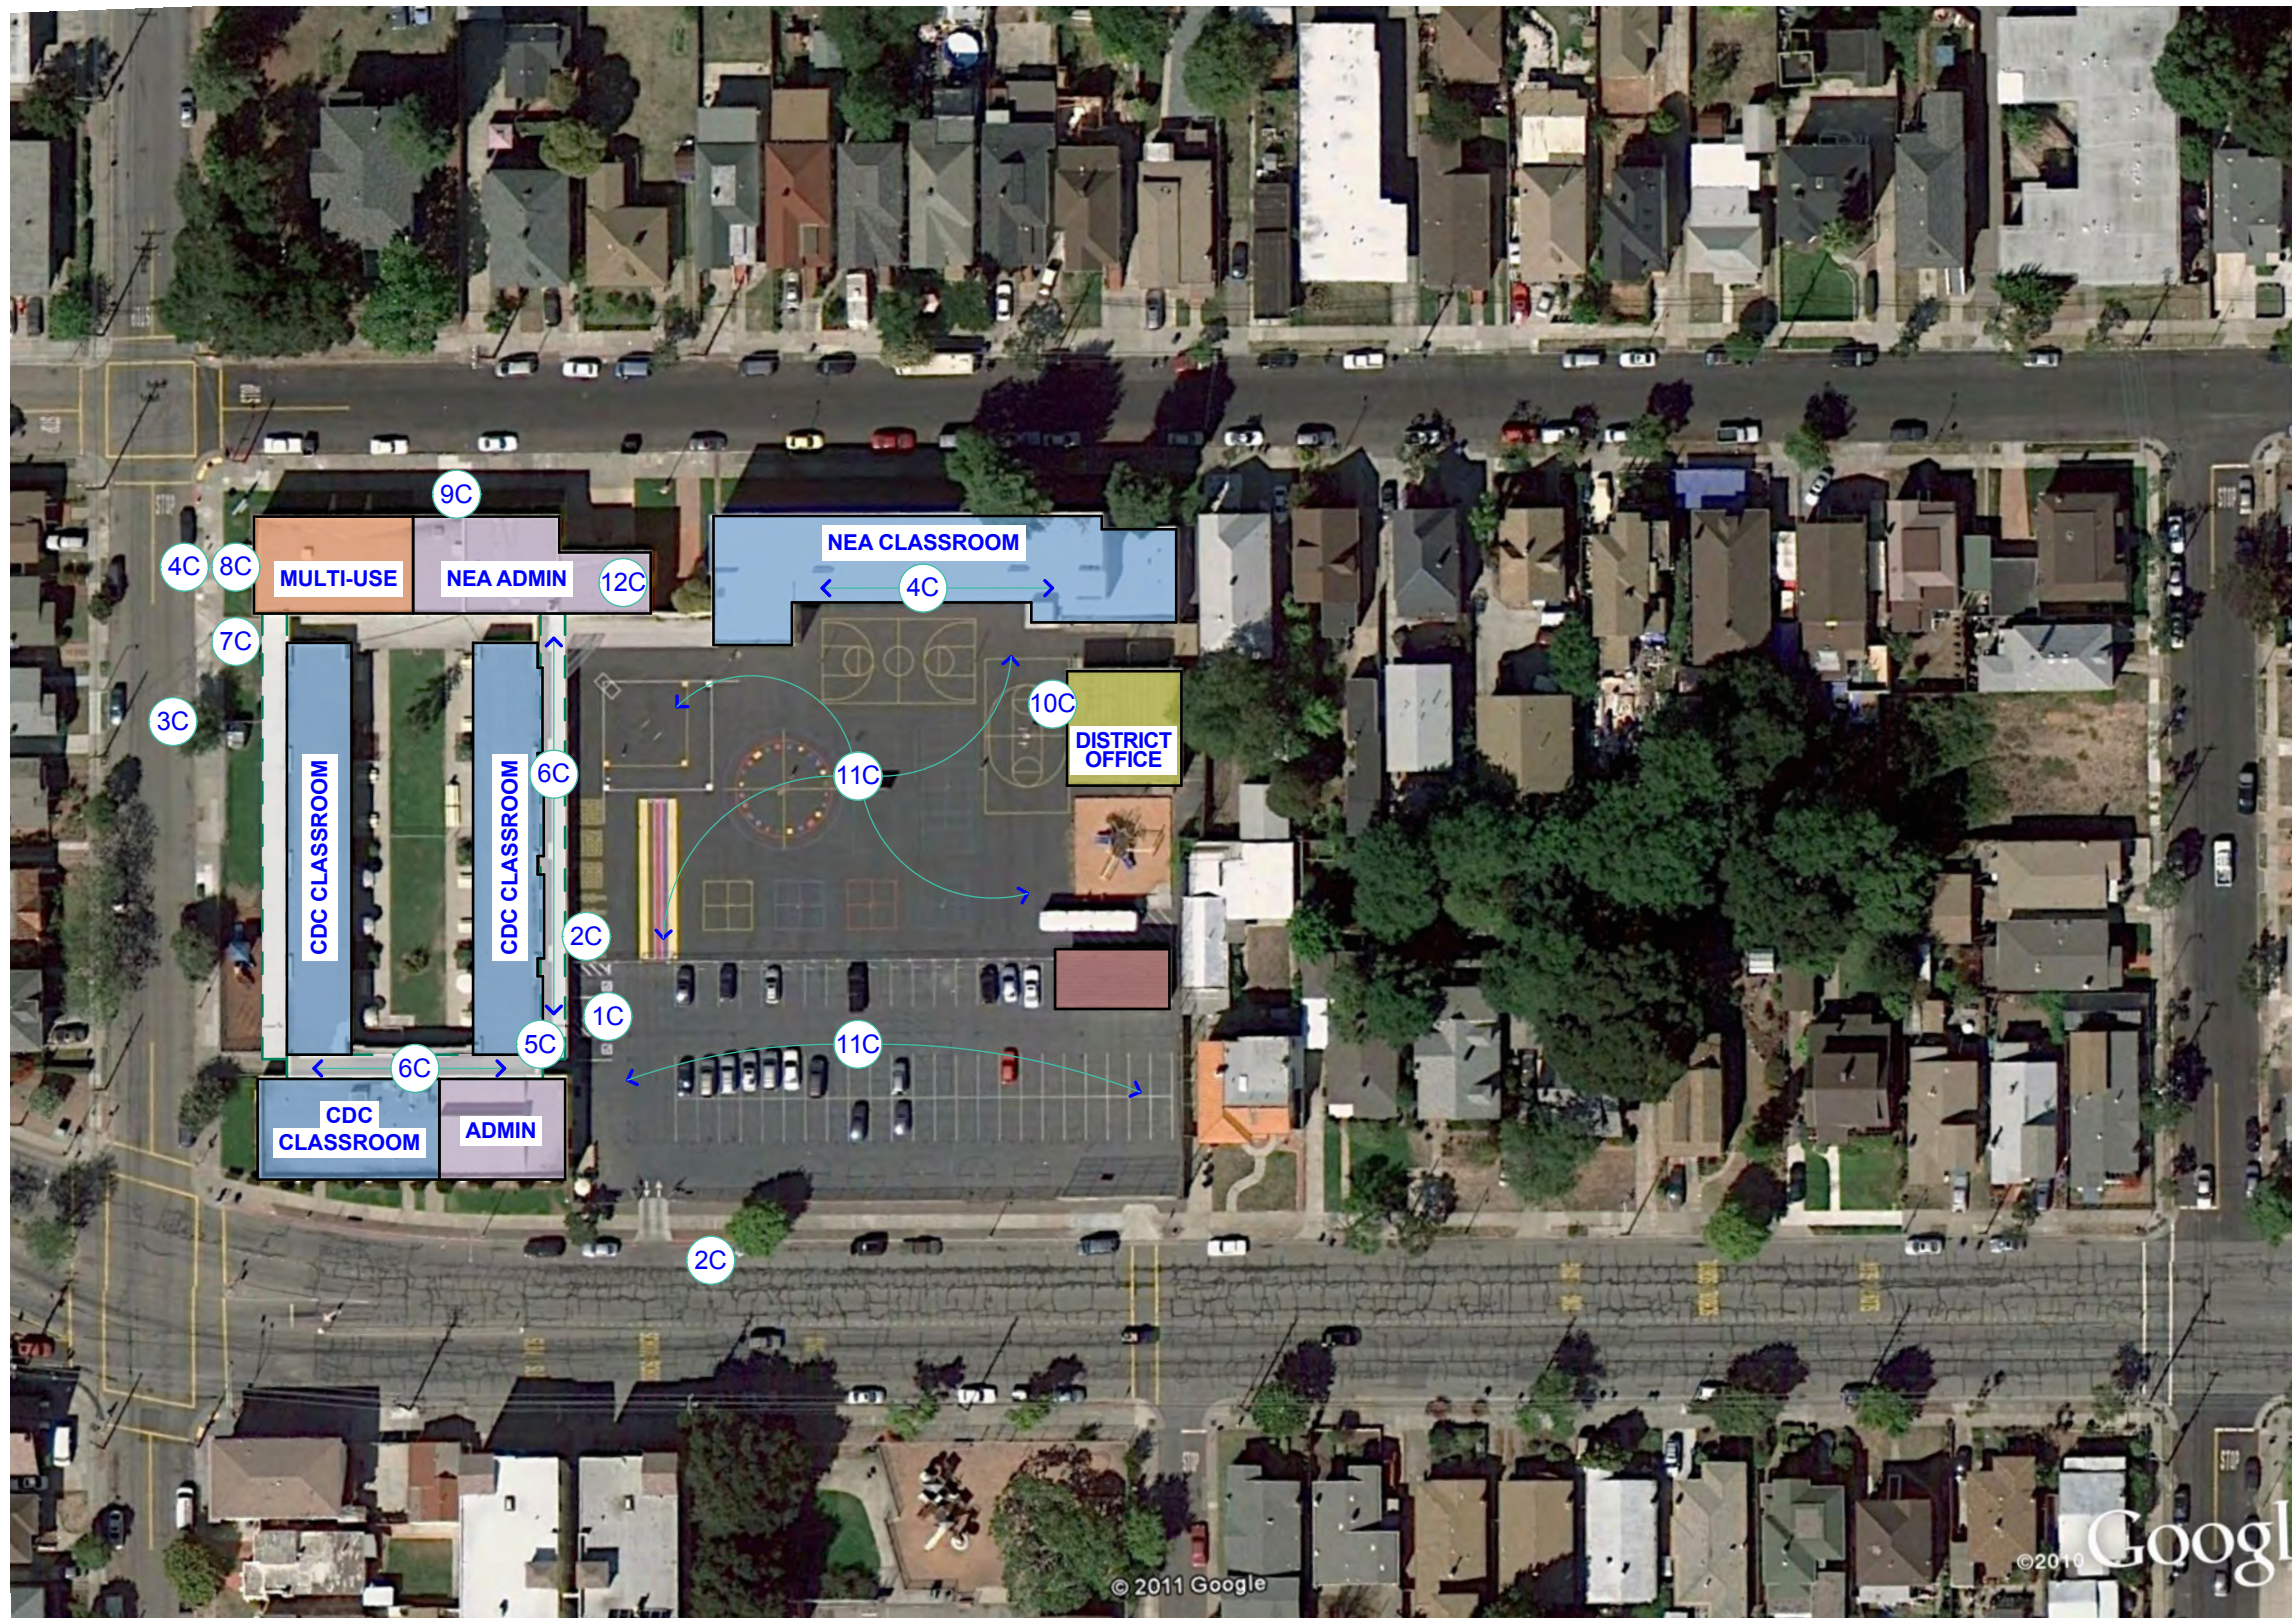
- CLASSROOM BUILDING
- ADMINISTRATION
- MULTI-PURPOSE / CAFETERIA BUILDING
- MODULAR BUILDING
- PORTABLE BUILDING
- COVERED WALKWAYS
- #C SEE ASSESSMENT SPREADSHEET FOR CIVIL KEYNOTES, TYP.

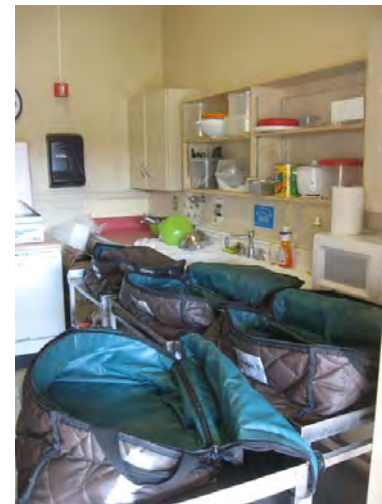
21

7 Existing Deficiency	NEA 2-Story Classrooms: sinks are non-compliant; 2nd Fl. Drink fountain is non-compliant for door clearance	#21, #22				
Recommended Remedy	Replace or remove classroom sinks; relocate D.F.		8	Sinks	\$3,200.00	\$25,600
