Franklin Elementary School

FRANKLIN ES
4/30/2012

Alameda USD Facilities Assessment

Franklin Elementary School
Facility Assessment Spreadsheet

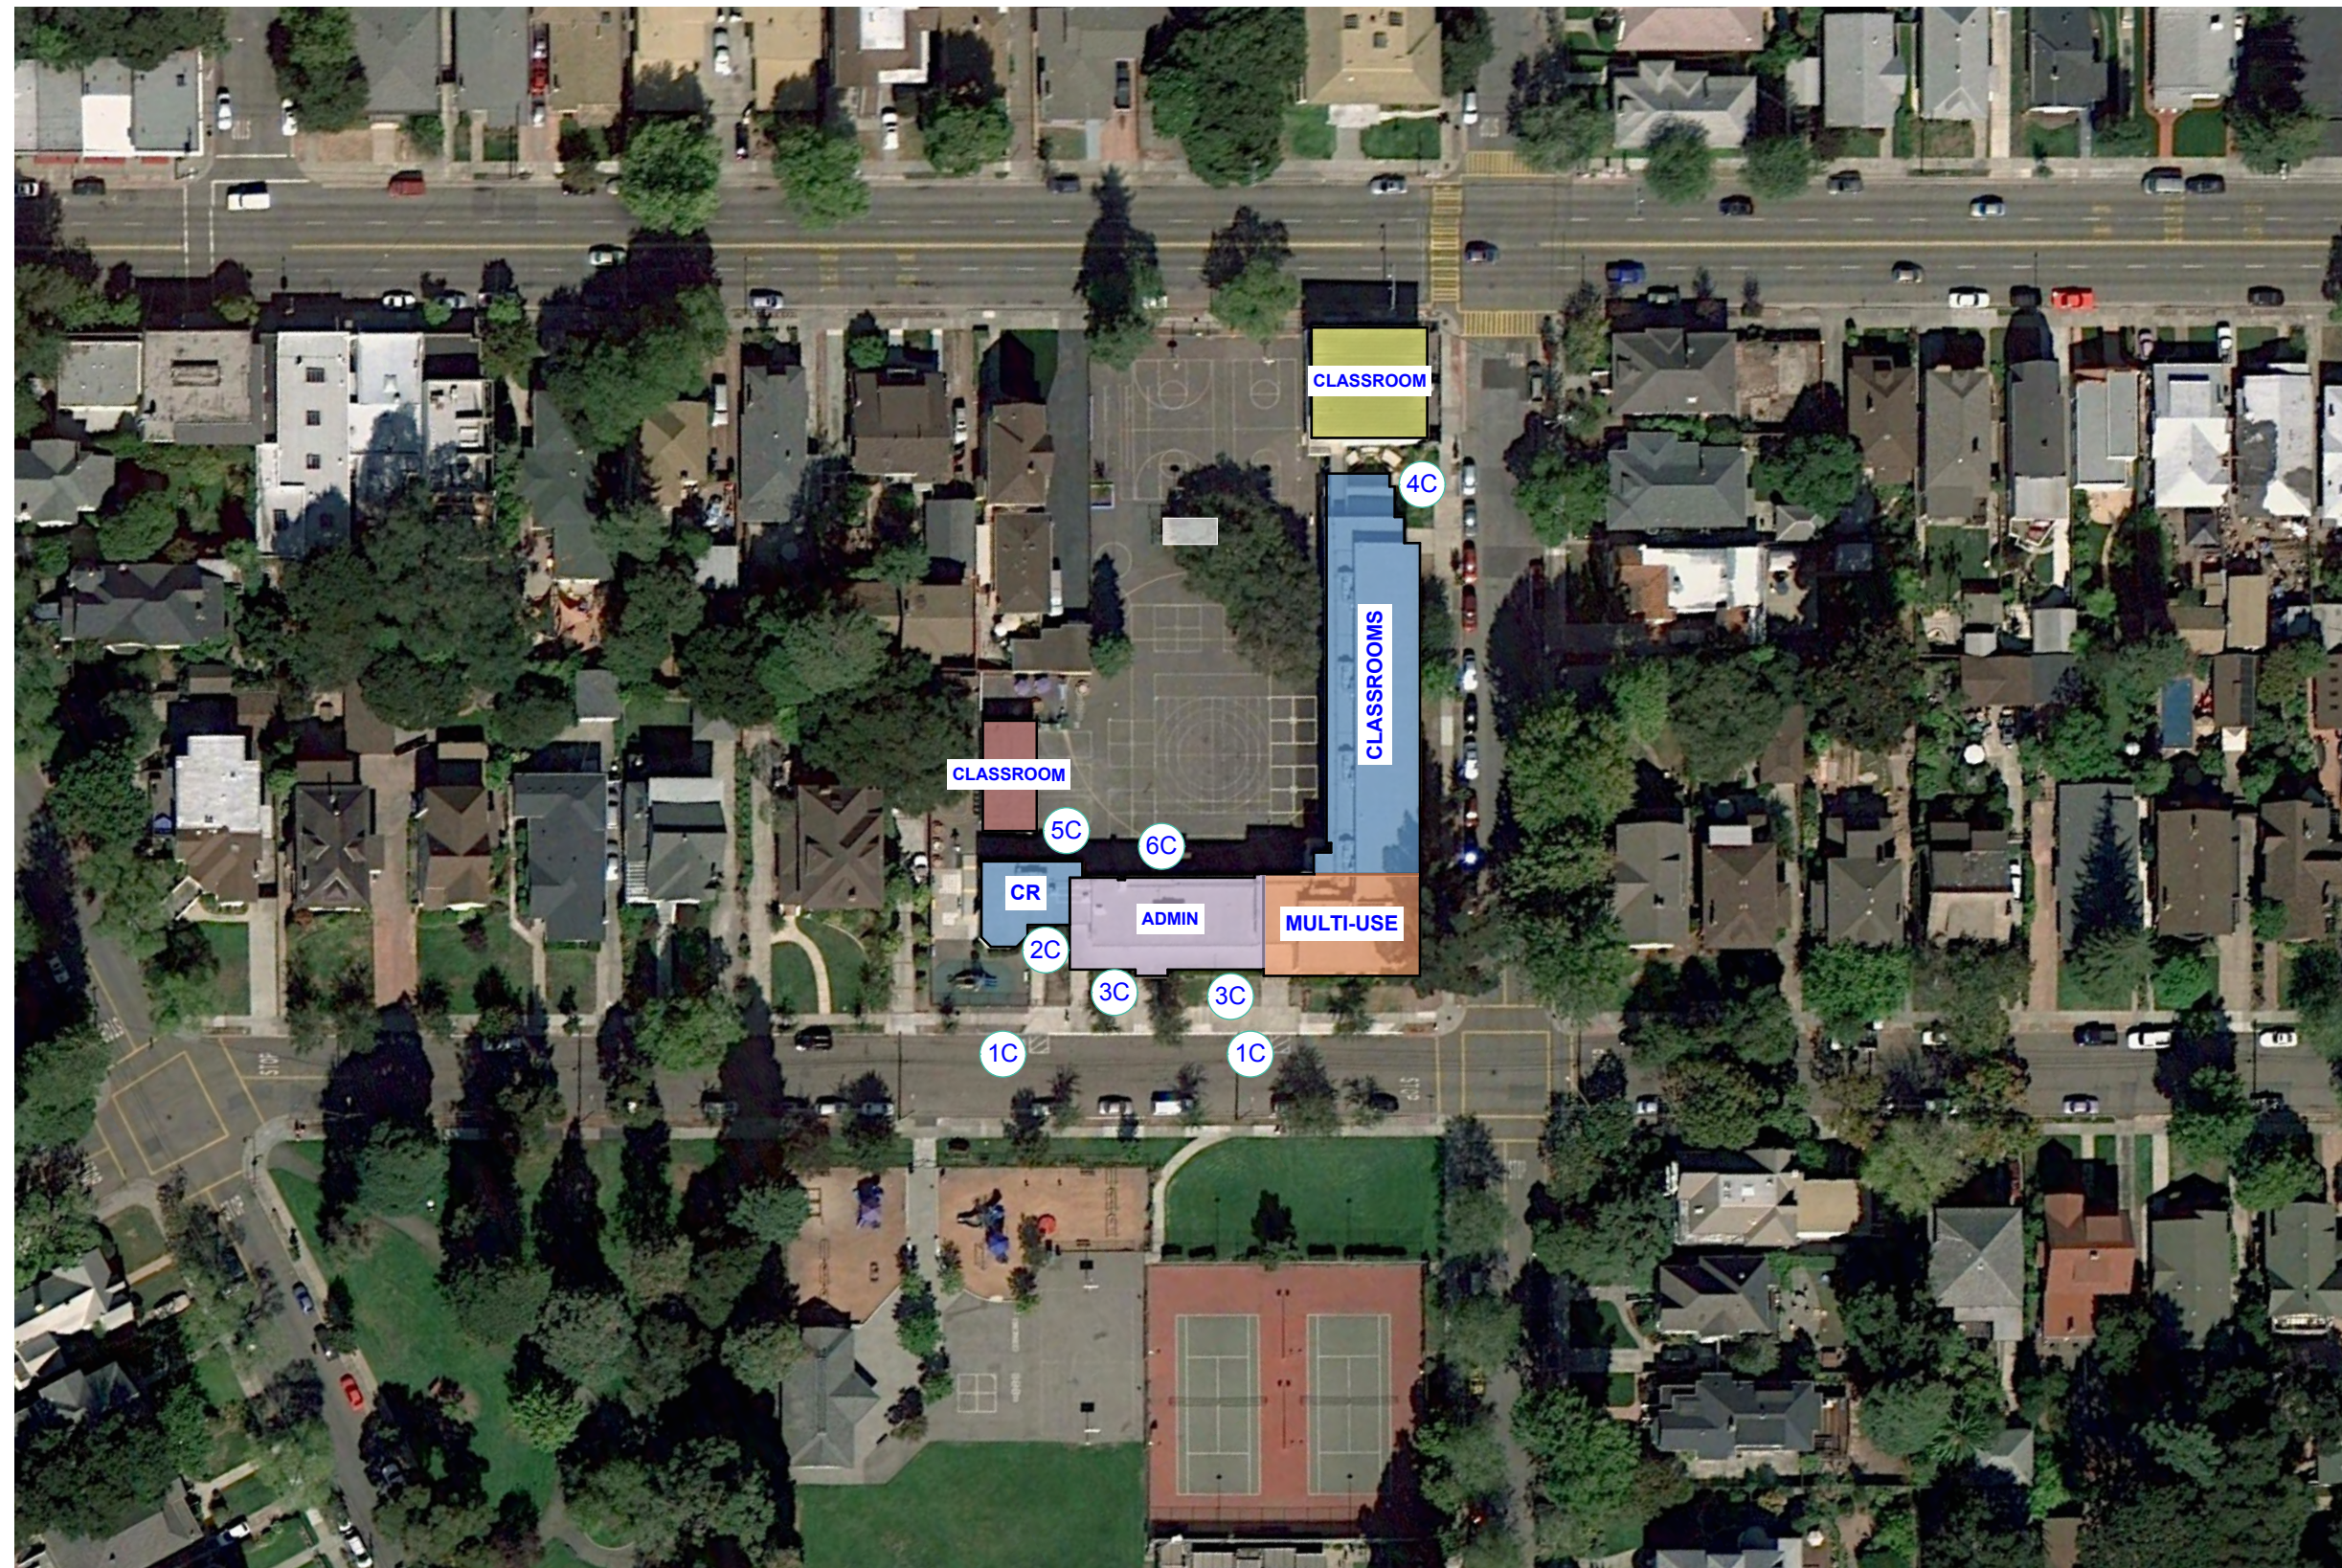
- CLASSROOM BUILDING
- ADMINISTRATION
- MULTI-PURPOSE / CAFETERIA BUILDING
- MODULAR BUILDING
- PORTABLE BUILDING
- COVERED WALKWAYS
- #C SEE ASSESSMENT SPREADSHEET FOR CIVIL KEYNOTES, TYP.

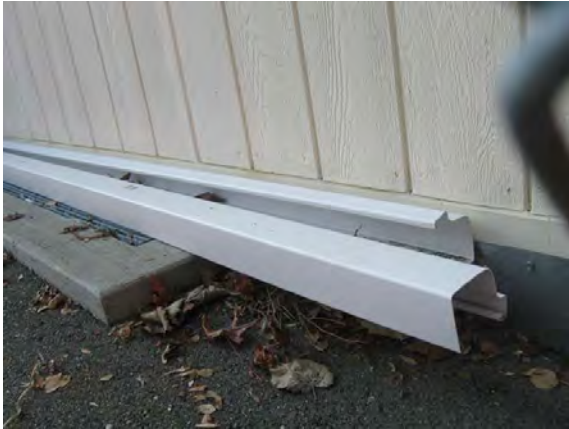
21

CATEGORY		DESCRIPTION	PHOTO & SITE PLAN	ESTIMATED TAKE OFF		COST / UNIT	TOTAL COST
				Quantity	Unit		
6	Existing Deficiency	Roof: BUR roofing at end of service life					
	Recommended Remedy	Replace all roofing, scuppers, caps and flashings		18,000	SF	\$9	\$162,000
7	Existing Deficiency	Brick Entry: steps are degraded and cracked	#7, #3				
	Recommended Remedy	Replace with cast concrete stair		240	SF	\$42	\$10,080
8	Existing Deficiency	Alum. windows: south and west facing units have reached end of service life.	#8, #13, #14				
	Recommended Remedy	Replace all exterior windows with alum. frame, dual pane glass		2,800	SF	\$38	\$106,400
9	Existing Deficiency	Portable C16: wood foundation dry rot; wood panel and trim paint degraded; no site drainage	#12, #15, #16				
	Recommended Remedy	Replace wood foundation with concrete; add site drainage and new RWLs.		15	CY	\$900	\$13,500
10	Existing Deficiency	2-Story Modular: south, west and east exterior paneling/ trim degrading.	#22

Recommended Remedy	Replace south, west and east exterior w/ cement panel/trim and repaint.		12,600	SF	\$12	\$151,200
11	Existing Deficiency	Modular Stairs/Rails: excessive rust; expansion gap at alum ramp to Bldg. exceeds max. for accessibility.	#17, #18				
	Recommended Remedy	prep, treat and repaint all steel; add expansion cover at gap..		2	SETS	\$18,000	\$36,000
