Woodstock Education Center (Woodstock ES)

SUMMARY OF SCHOOL CAMPUS

Woodstock Education Center
4/30/2012

Alameda USD Facilities Assessment

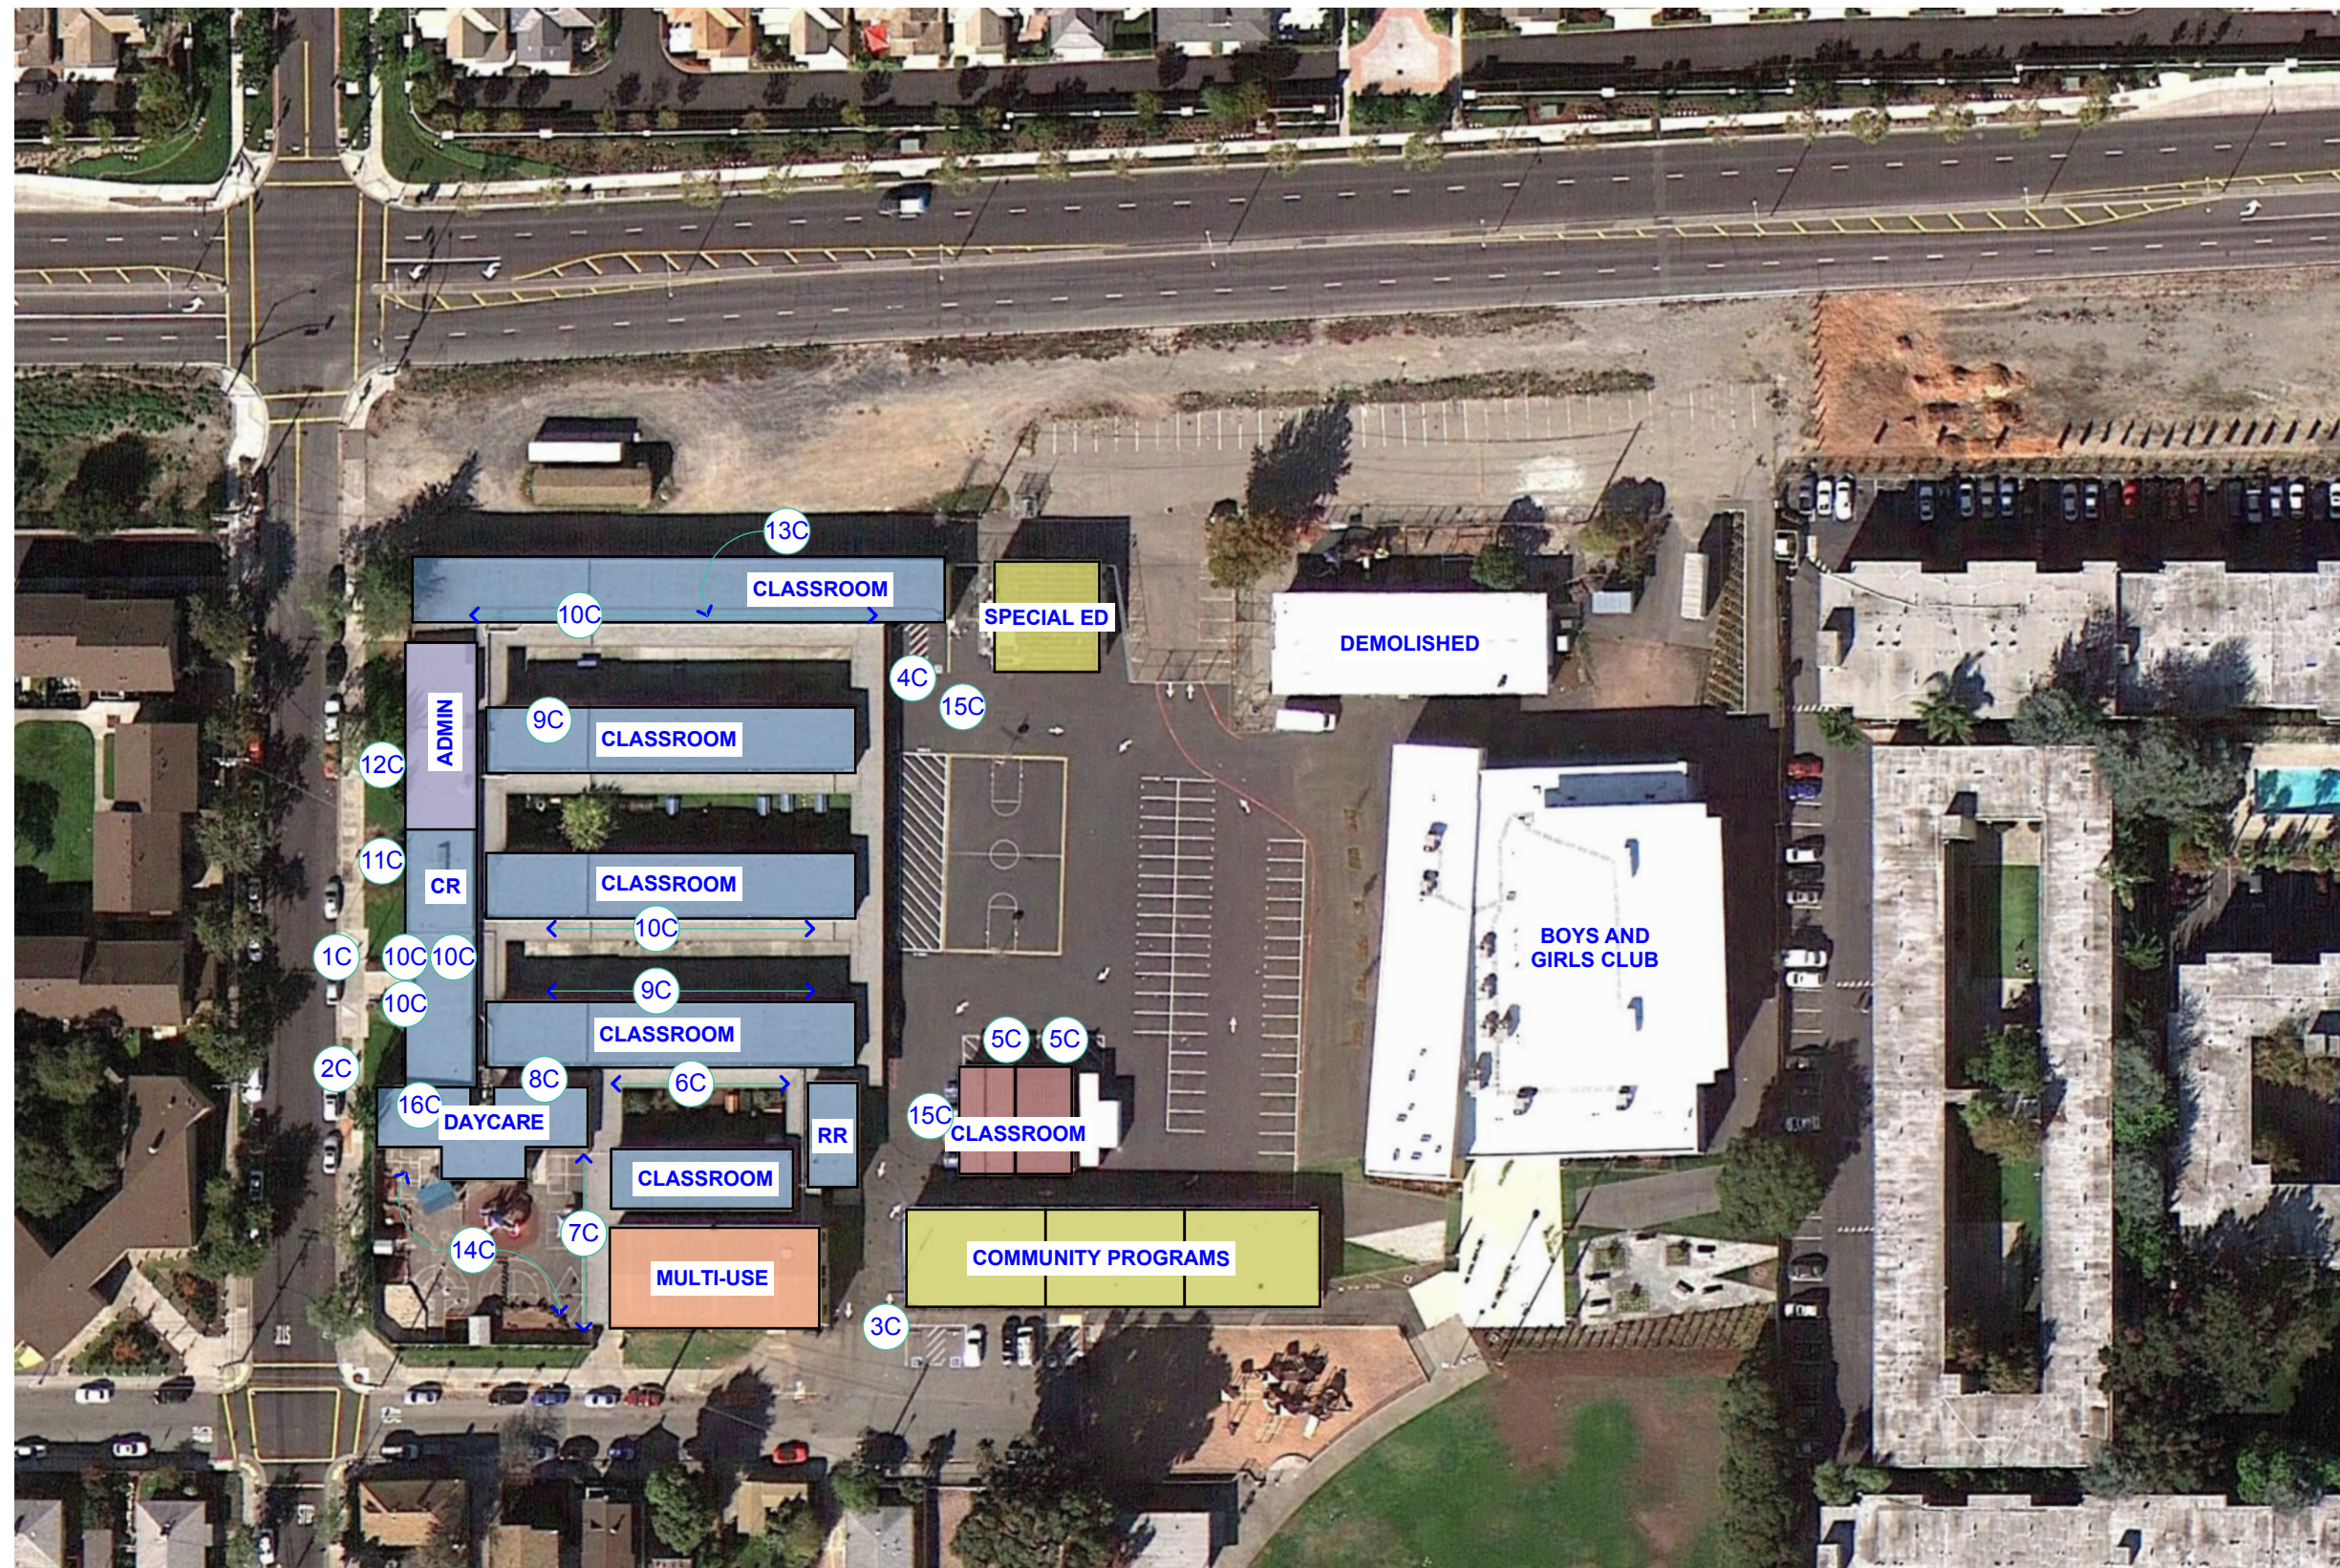
- CLASSROOM BUILDING
- ADMINISTRATION
- MULTI-PURPOSE / CAFETERIA BUILDING
- MODULAR BUILDING
- PORTABLE BUILDING
- COVERED WALKWAYS
- #C SEE ASSESSMENT SPREADSHEET FOR CIVIL KEYNOTES, TYP.
